# TECHNICAL REPORT

Prepared by: Andes GMS SpA

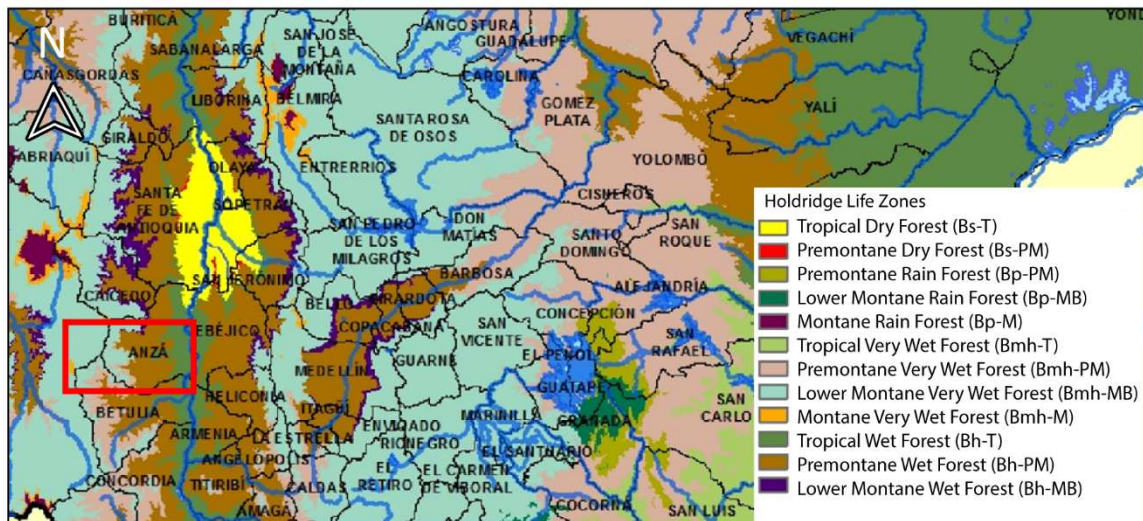
Figure 4: Holdridge life zones system classification in Antioquia. (Take from a study of Minera Anzá (n.d.)).

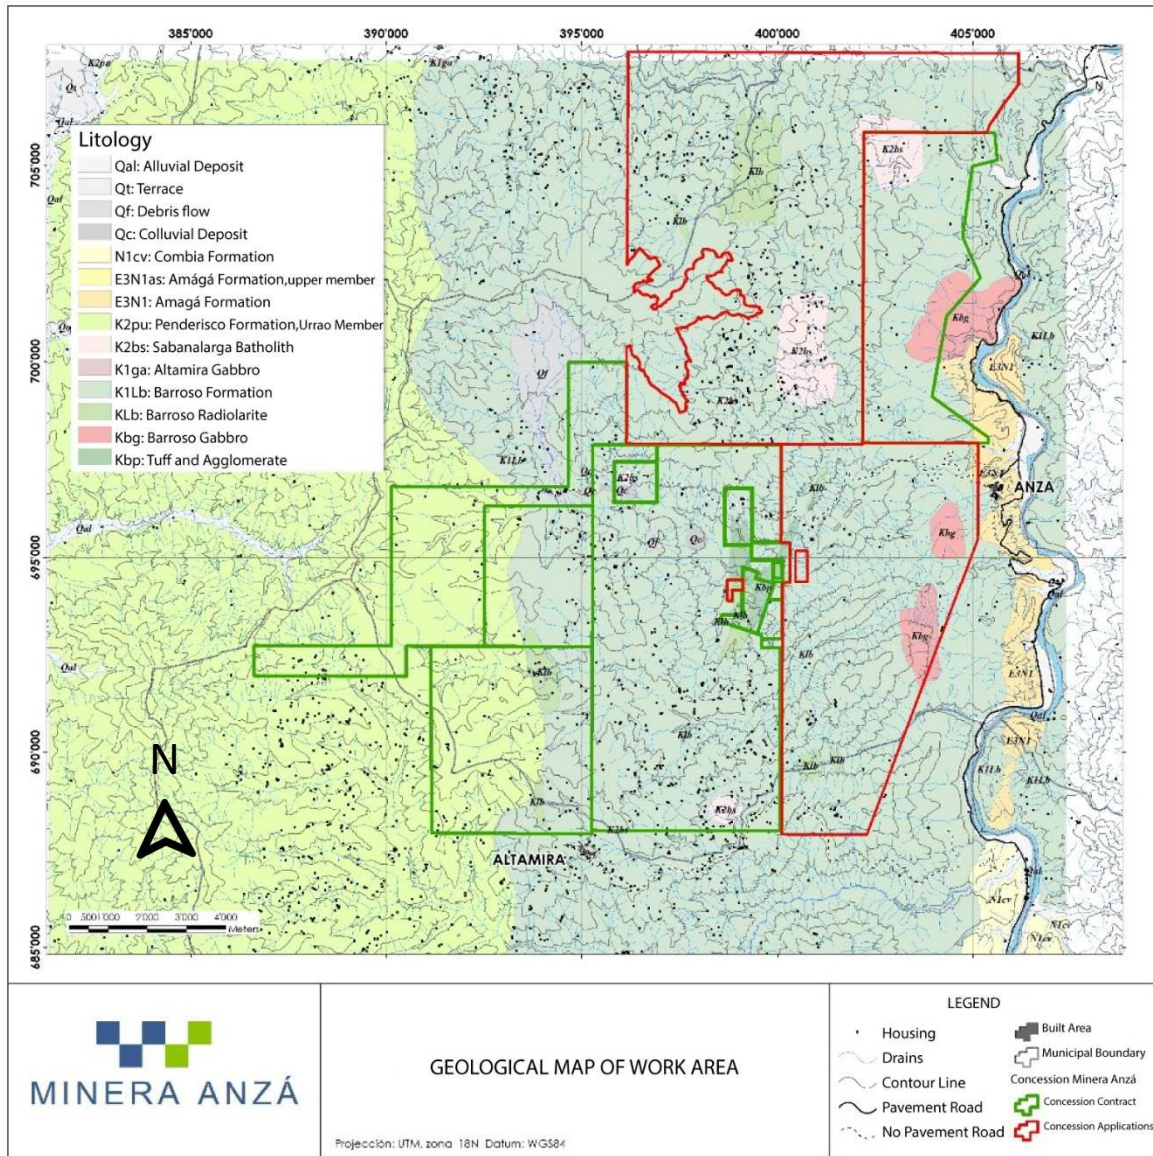
**Figure 10:** Geological map of the Project area; Green polygons are the titles and the red polygons are requests from Minera Anzá ((Minera Anzá (2018). Minera Anzá report to Ministry of mines/Ministerio de Minas).

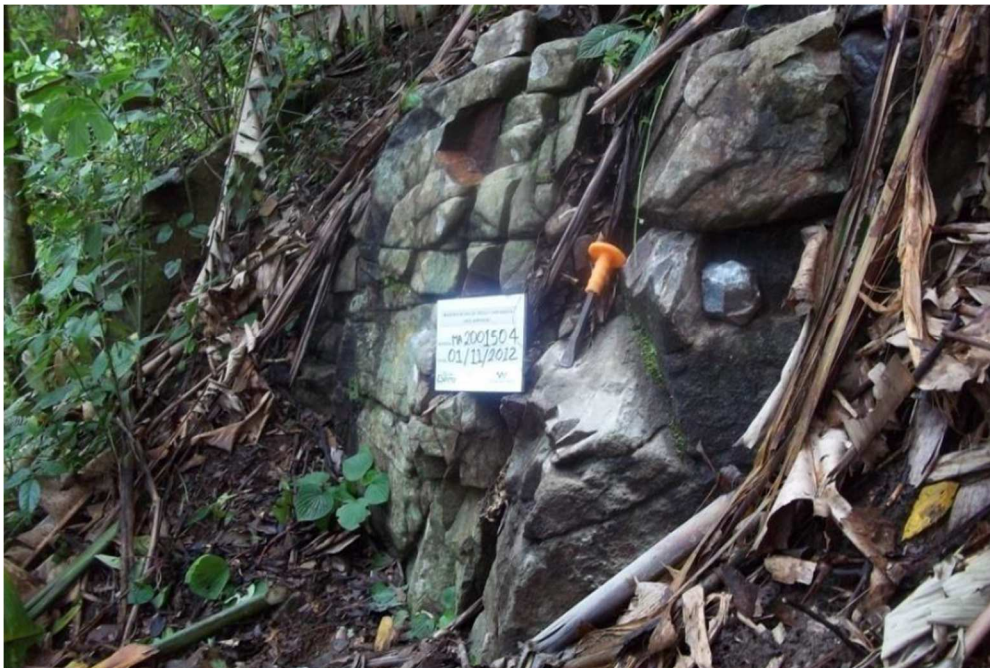
**Photo 1:** Diorite outcrop in the “vereda” La Cejita (Gemi, 2012).

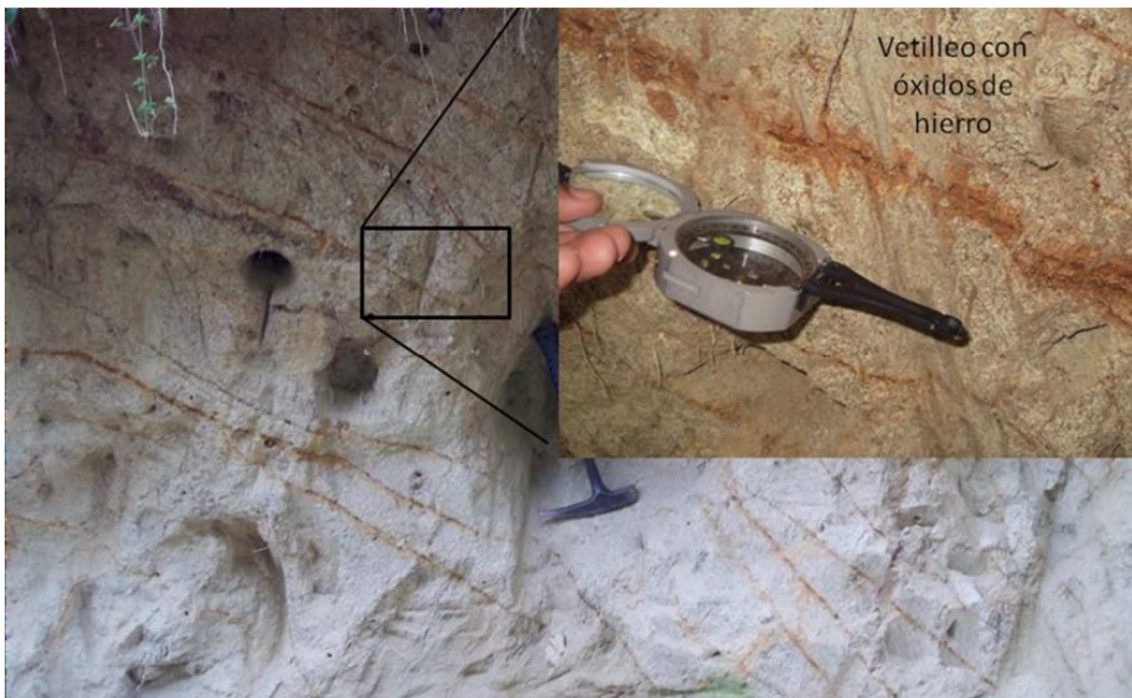
**Photo 3:** Oxides of iron veinlets in the road of La Cejita - Lo Mata (Gemi, 2012).

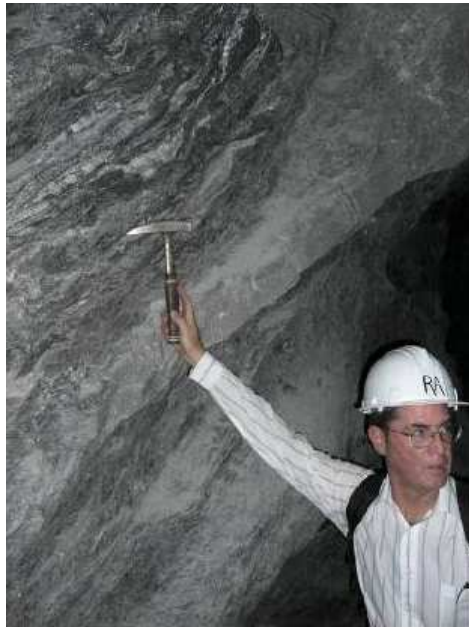
**Photo 4:** Bands of gypsum with intercalations of black shale, underground mine in La Pastorera (Snowden, 2007).

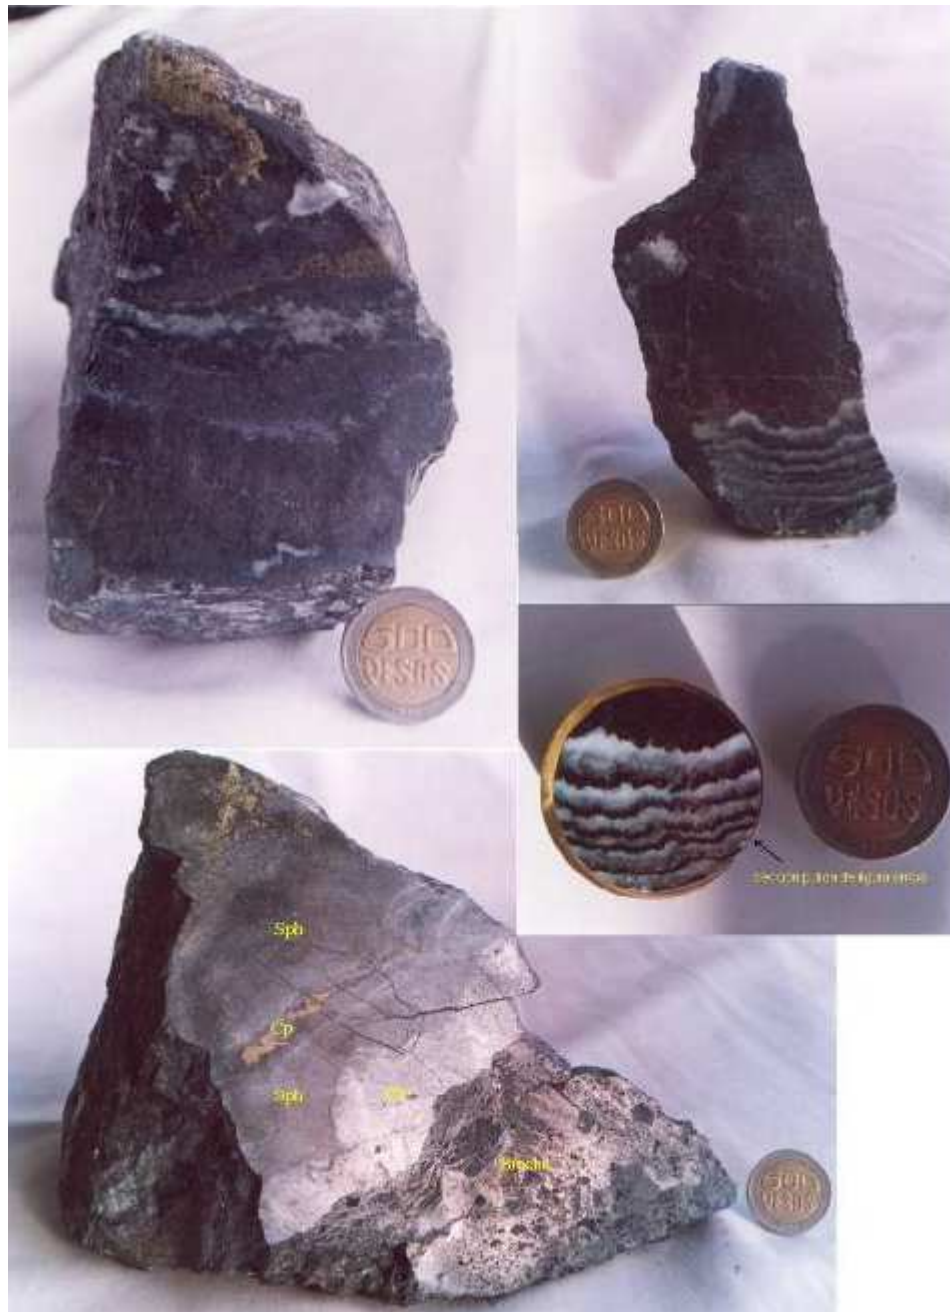
**Photo 6:** Photographs of massive sulphide material in thin sections of La Pastorera (Snowden, 2010)

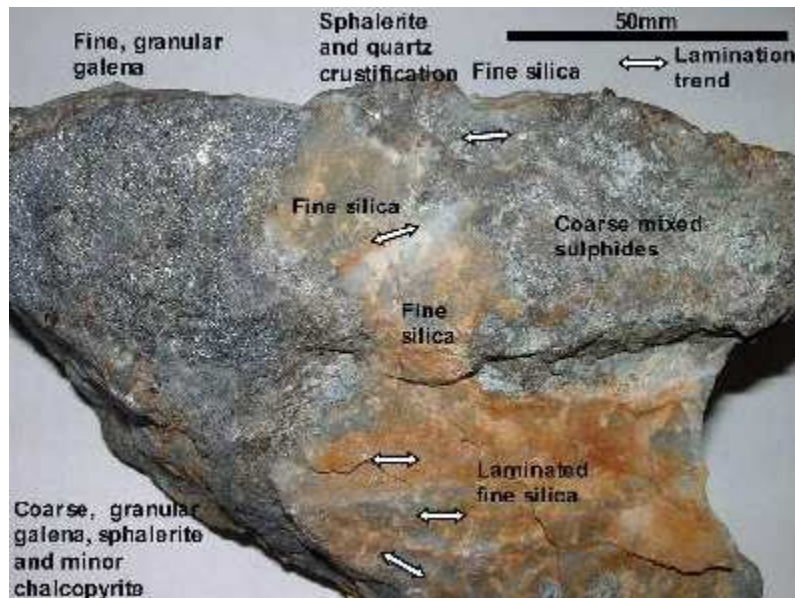
**Photo 7:** Sulphide massive hand sample collecting by Snowden (Snowden, 2010).

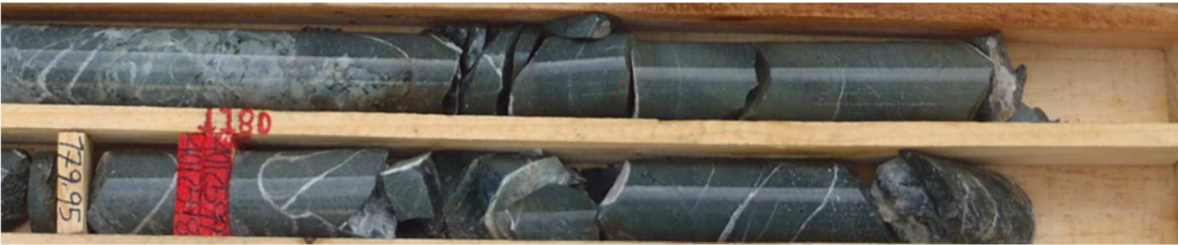
**Photo 13:** Tuff: Fine to medium rock of grey to green olive colour. It presents veinlets of quartz/calcite and epidote/Quartz. Silicification moderate to low, overprinted and argillization in fractures. Sometimes it is intercalated with mudstones (Logging of geological drilling, Minera Anzá (2017)).

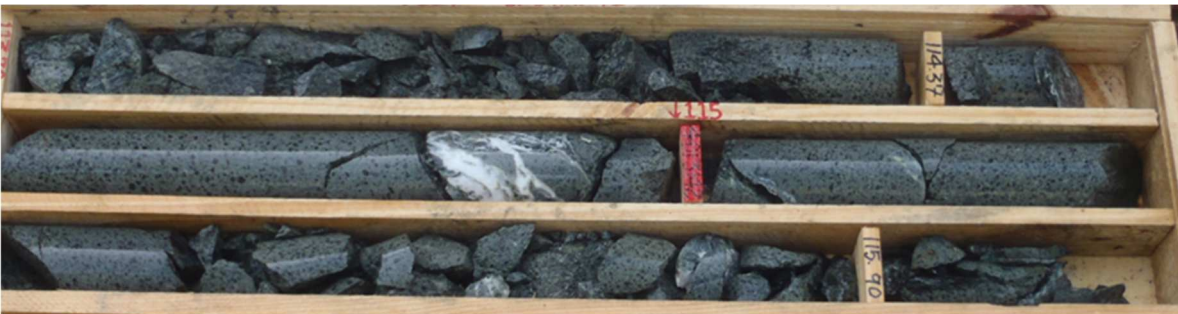
**Photo 14:** Mafic dyque: Dyque of green colour, porphyritic texture (amphibol euhedral porphyroblasts). It has veinlet of quartz/calcite. Chlorite alteration pervasive and moderate silicified (Logging of geological drilling, Minera Anzá (2017)).

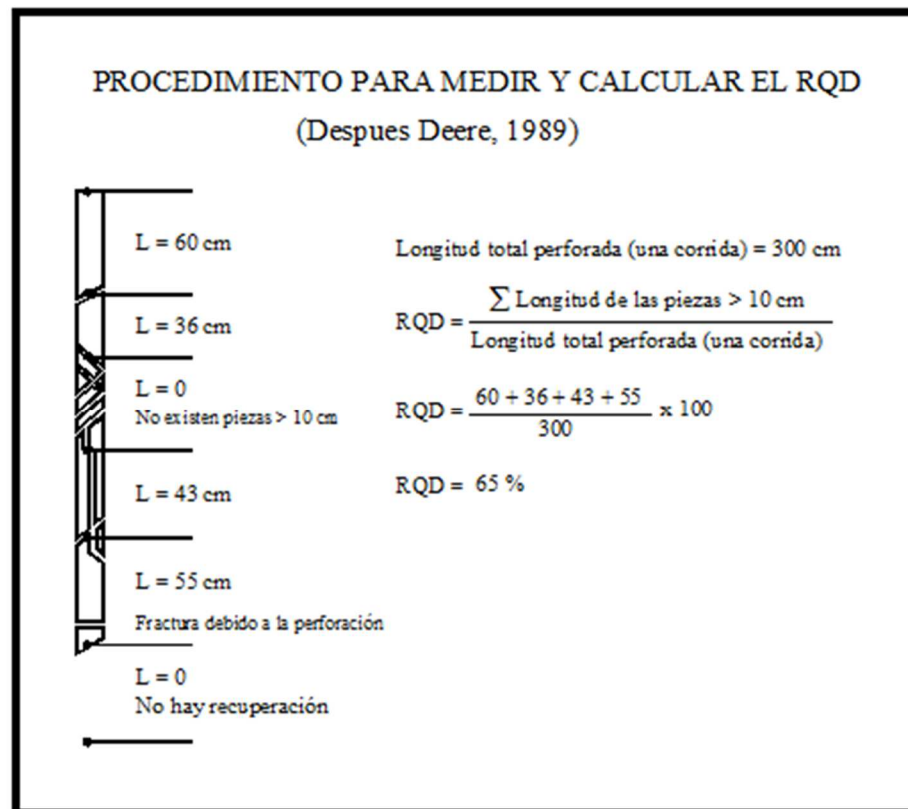
**f) Hardness index (Logging of geological drilling, Minera Anzá (2017)).**

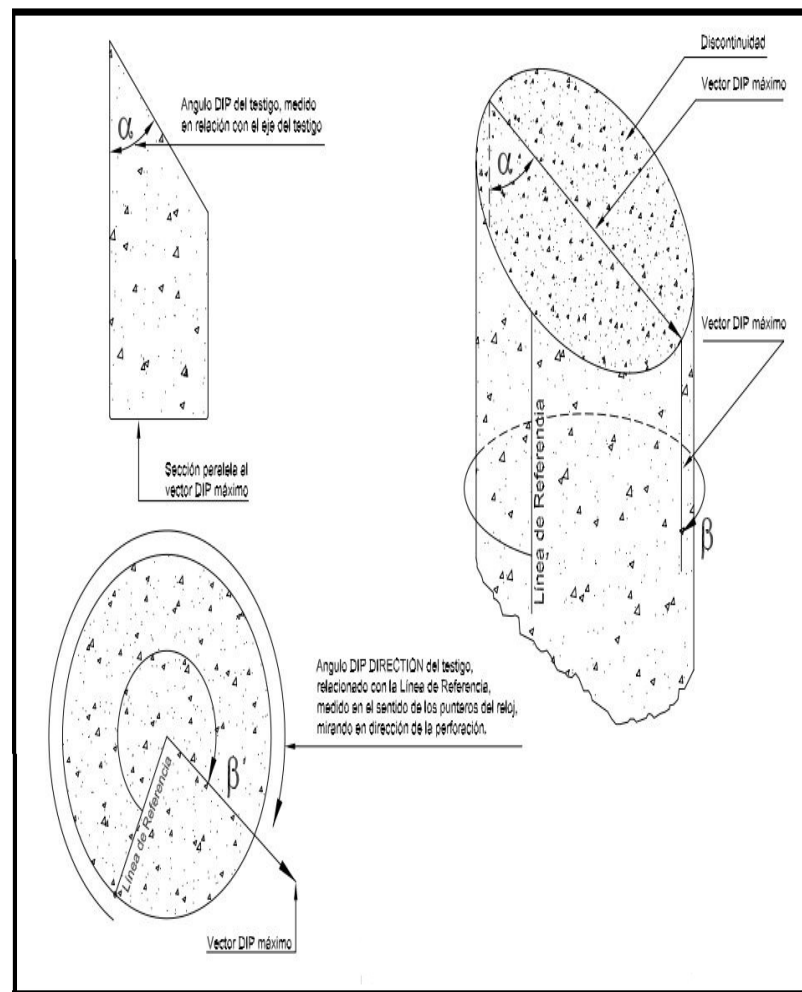
**Figure 58:** Dip angle and dip direction angle in a drill-hole (Logging of geological drilling, Minera Anzá (2017)).

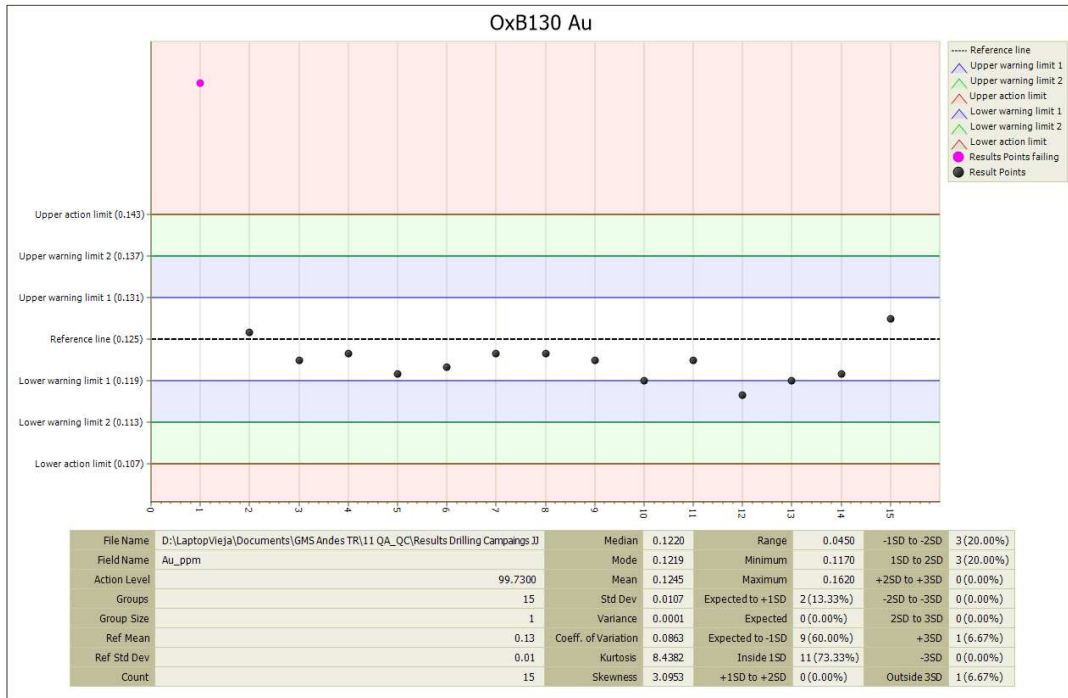
**Figure 59:** Standard deviation graph for sample OxB130 Au. Shows only one failed sample, the graph shows good accuracy and precision (Flash report QA / QC, Minera Anzá (2018)).

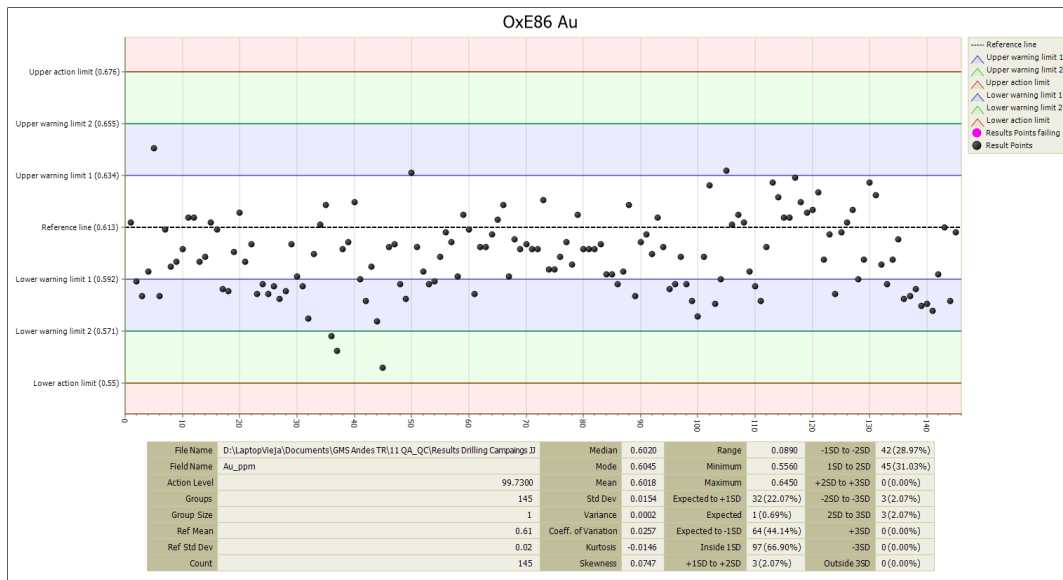
**Figure 60:** Standard deviation graph for sample OxE86 Au. It does not show any failed sample and all samples have accuracy and precision in the laboratories (Flash report QA / QC, Minera Anzá (2018)).

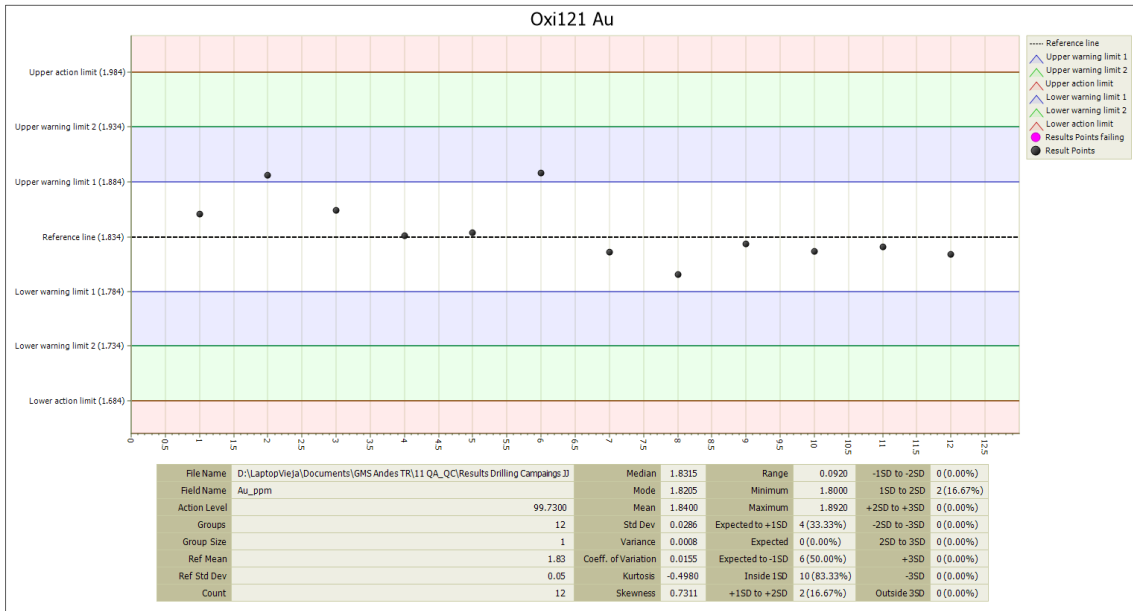
**Figure 61:** Standard deviation graph for sample Oxi121 Au. This standard have few samples and any shows failed samples (Flash report QA / QC, Minera Anzá (2018)).

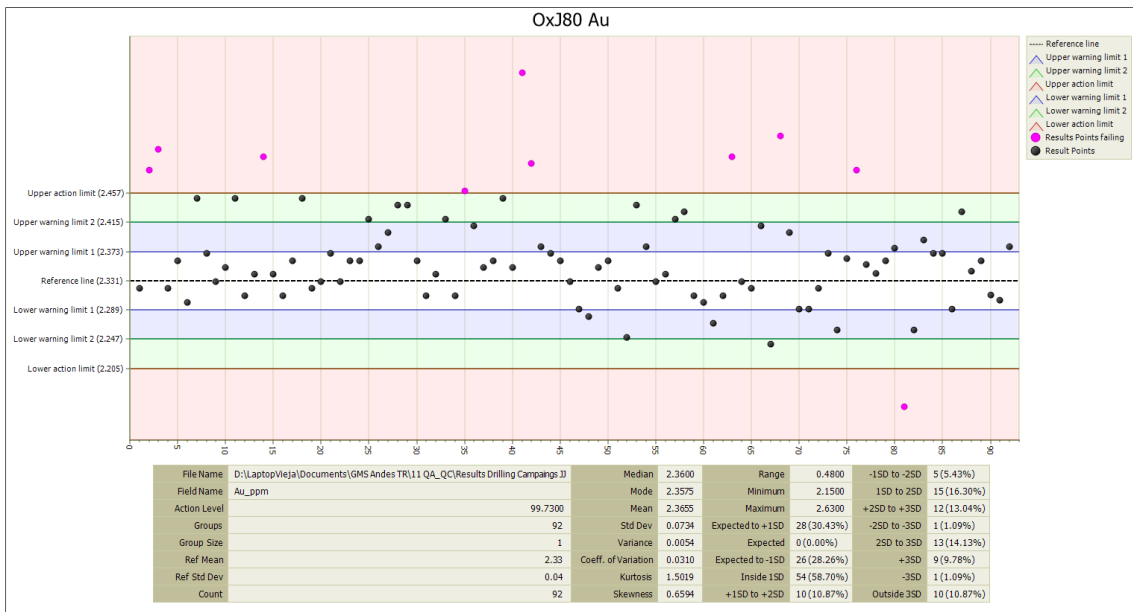
**Figure 62:** Standard deviation graph for sample OXJ80 Au. There is evidence of some kind of problem with this reference material, the results have positive bias and this behavior is observed distributed in homogeneous form meanwhile other reference materials have good behavior (Flash report QA / QC, Minera Anzá (2018)).

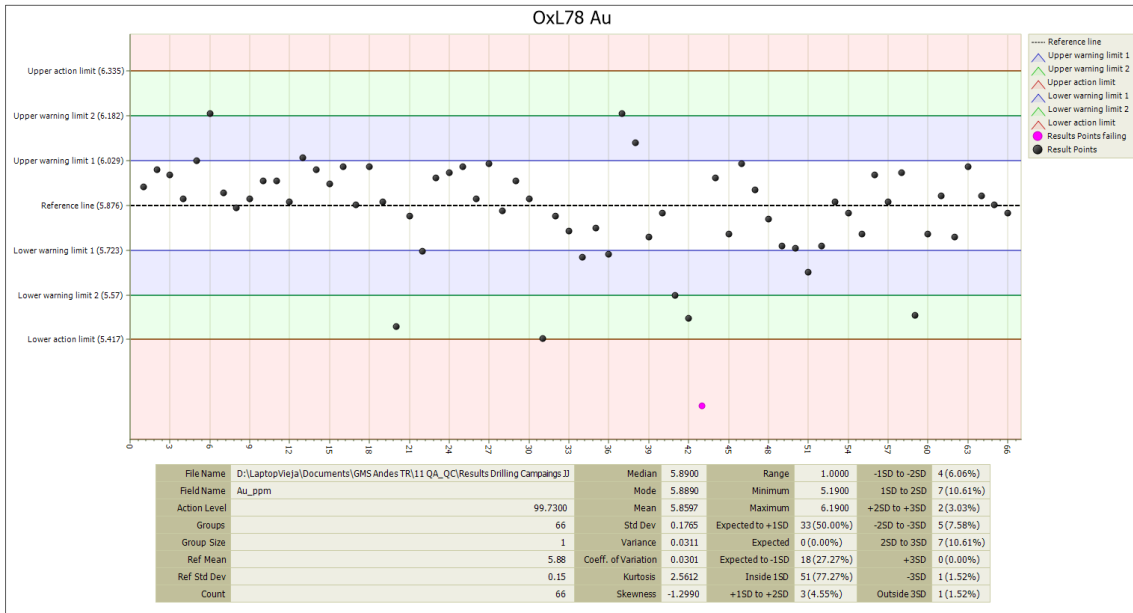
**Figure 63:** Standard deviation graph for sample OxL78 Au. Shows only one failed sample and all samples have precision and accuracy in laboratories (Flash report QA / QC, Minera Anzá (2018)).

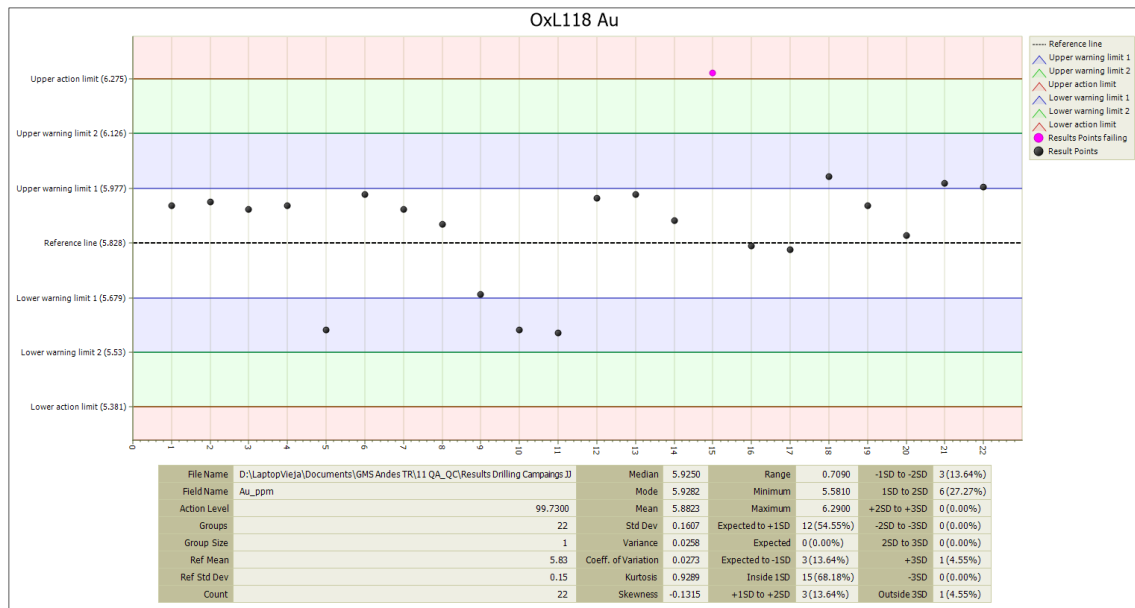
**Figure 64:** Standard deviation graph for sample OxL118 Au. Shows only one failed sample close to upper limit and all samples have precision and accuracy in laboratories (Flash report QA / QC, Minera Anzá (2018)).

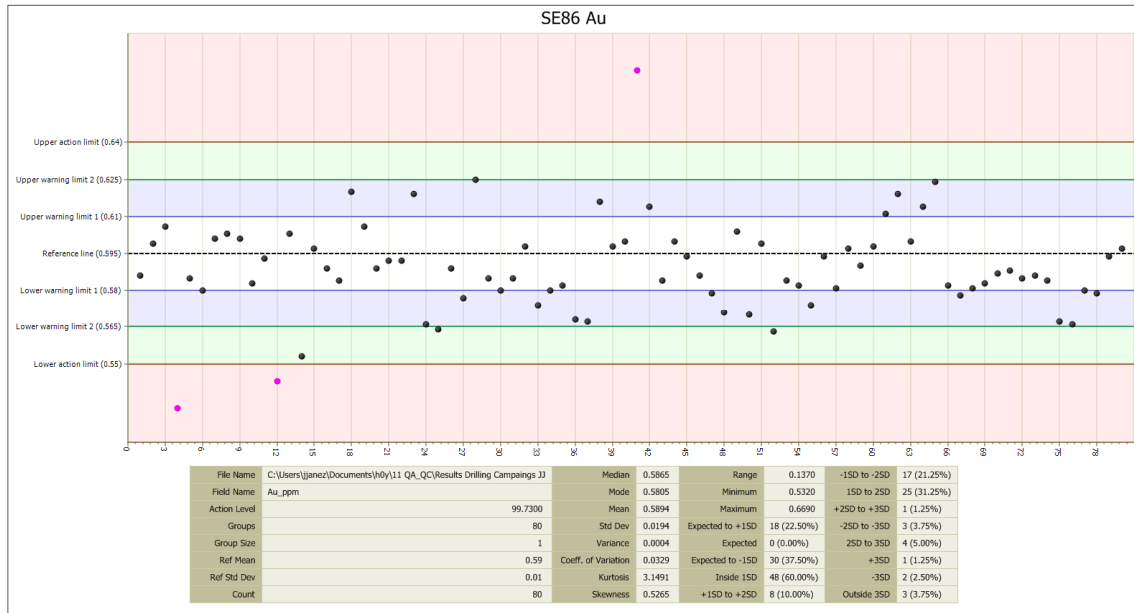
**Figure 65:** Standard deviation graph for sample SE86 Au. Shows only one failed sample and all samples have precision and accuracy in laboratories (Flash report QA / QC, Minera Anzá (2018)).

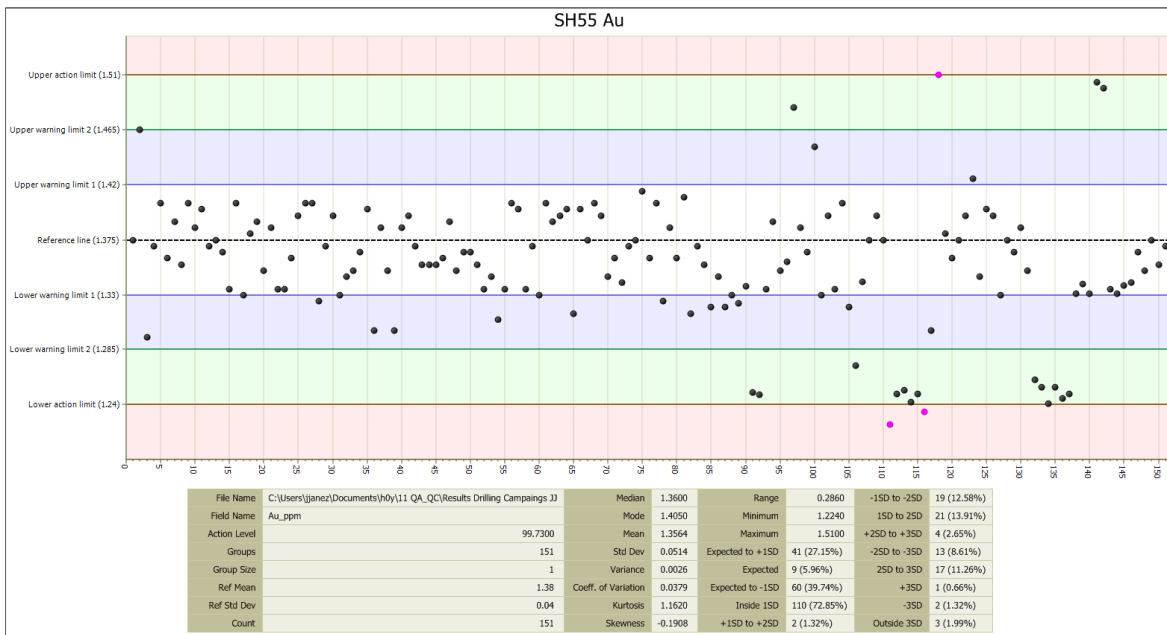
**Figure 66:** Standard deviation graph for sample SH55 Au. Shows three failed sample and all samples have precision and accuracy in laboratories (Flash report QA / QC, Minera Anzá (2018)).

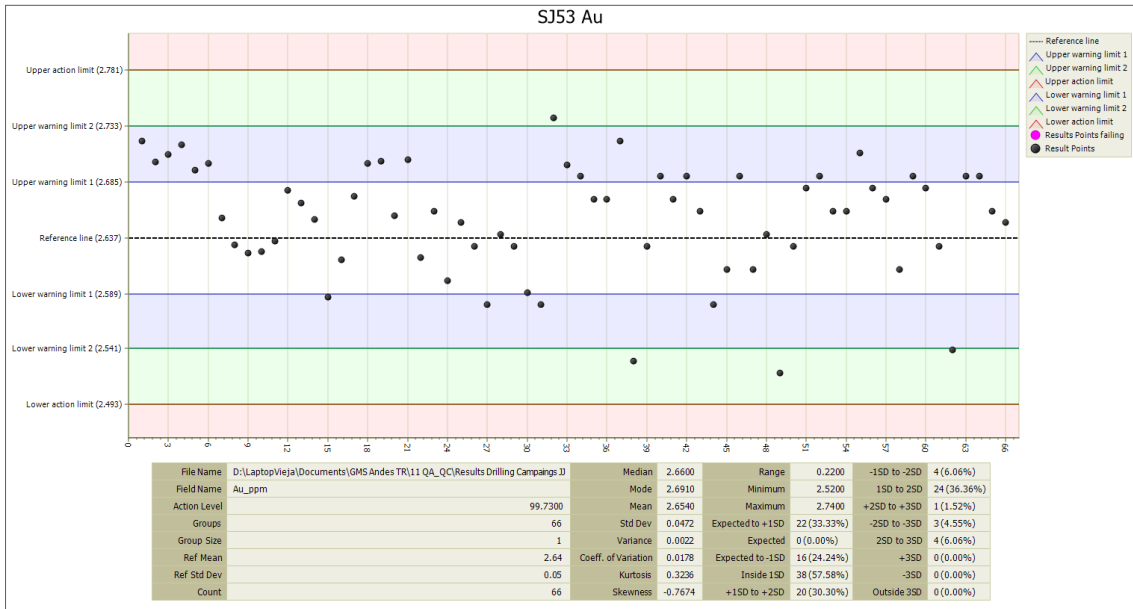
**Figure 67:** Standard deviation graph for sample SJ53 Au. It does not show any failed sample and all samples have accuracy and precision in the laboratories (Flash report QA / QC, Minera Anzá (2018)).

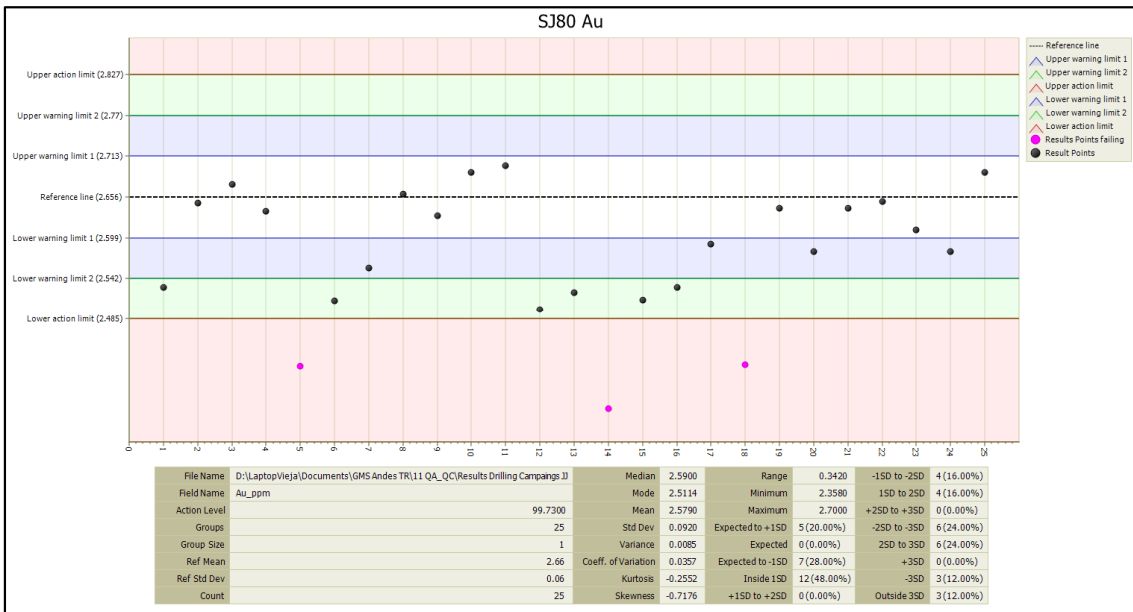
**Figure 68:** Standard deviation graph for sample SJ80 Au. Three samples (12%) of a relatively small group are rejected, bias is always negative and both laboratories have reject samples, also considering that the rest of the samples have negative bias with respect to the expected value (Flash report QA / QC, Minera Anzá (2018)).

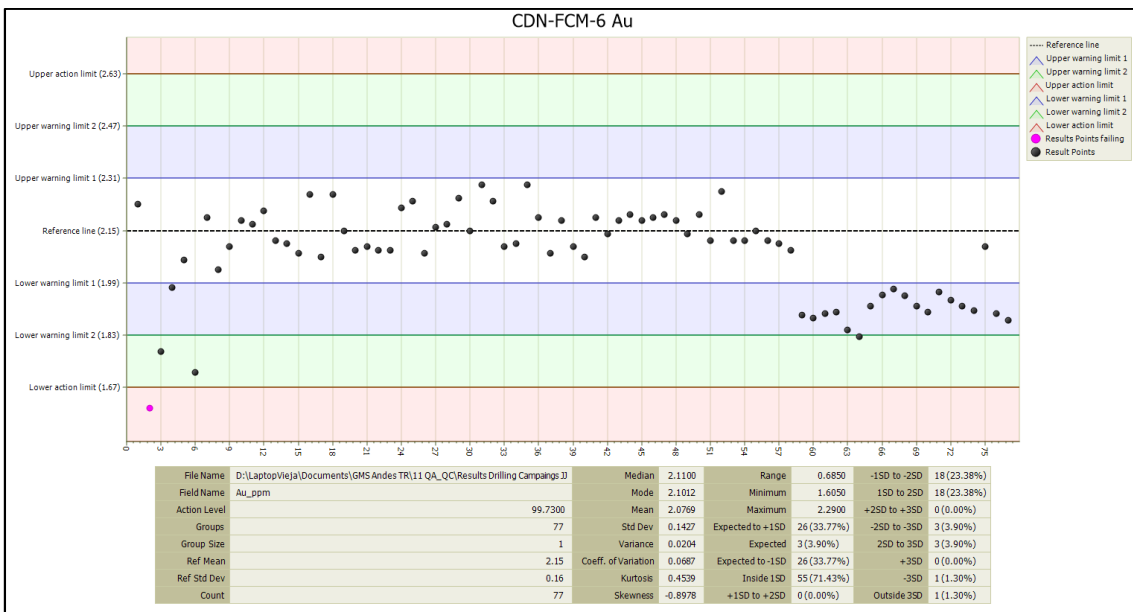
**Figure 70:** Standard deviation graph for sample CDN-FCM-6 Au. Shows only one failed sample and a certain number of samples have precision and accuracy in laboratories. There is a decrease in the accuracy of SGS in the Orosur campaign, although it remains been precise and within the acceptable limits (Flash report QA / QC, Minera Anzá (2018)).

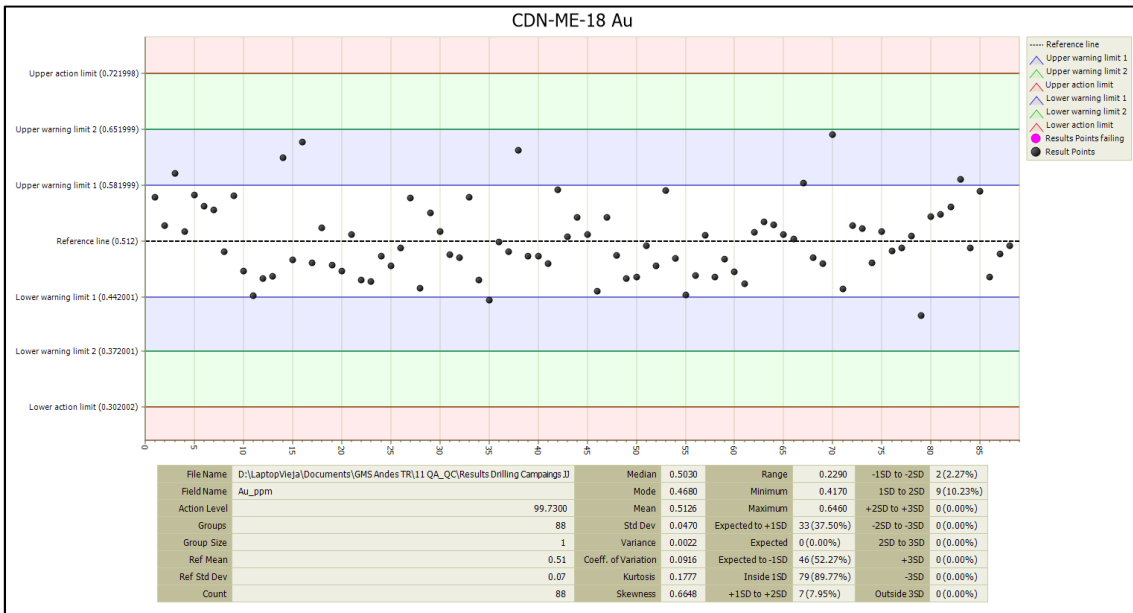
**Figure 71:** Standard deviation graph for sample CDN-ME-18 Au. It does not show any failed sample and all samples have accuracy and precision in the laboratories (Flash report QA / QC, Minera Anzá (2018)).

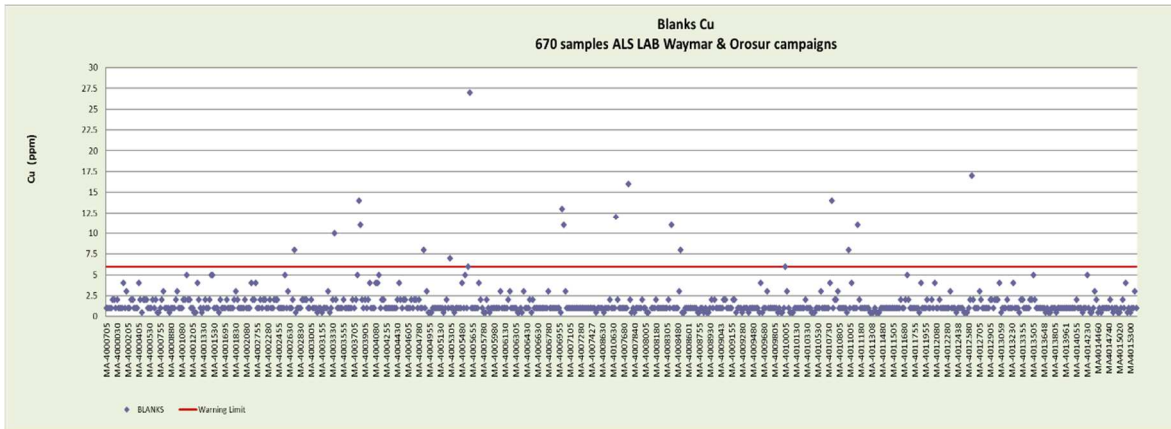
Figure 74: Blank analysis graph in Cu (Flash report QA / QC, Minera Anz  (2018)).

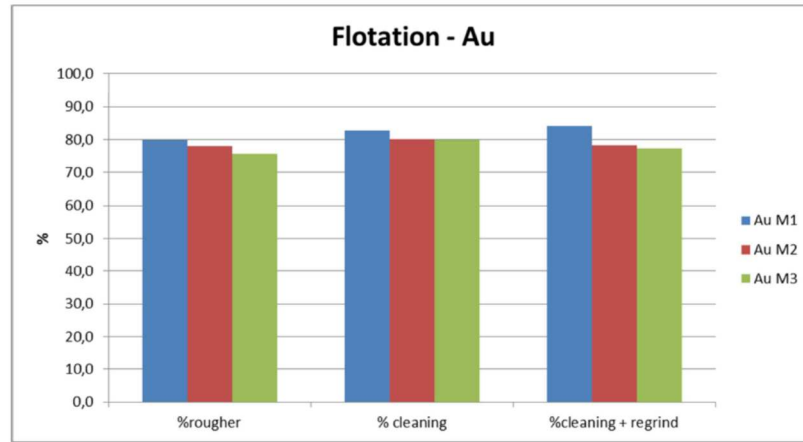
**Figure 90:** Recovery of Gold for the samples by flotation process for three different conditions.

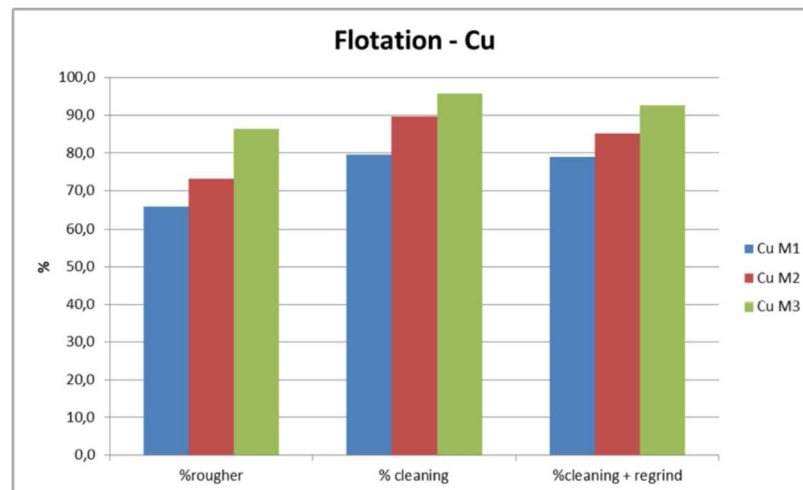
**Figure 91:** Recovery of Cooper for the samples by flotation process for three different conditions.

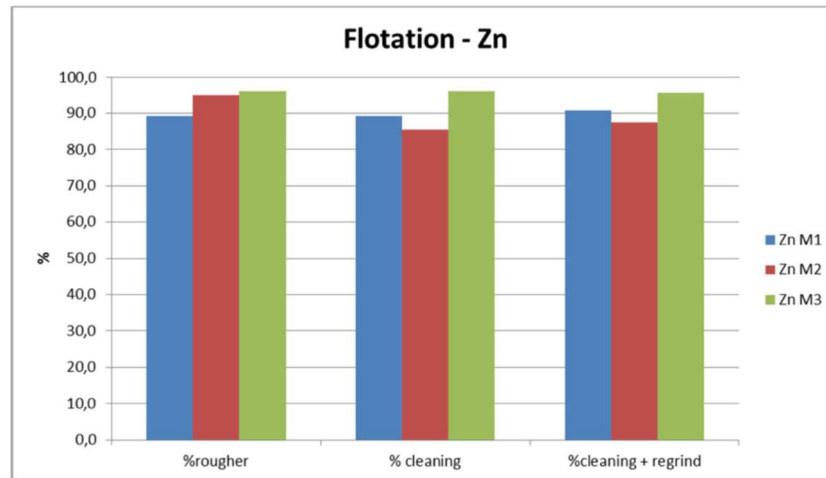
**Figure 92:** Recovery of Zinc for the samples by flotation process for three different conditions.
